RESULTS OF FIELD TRIALS OF THE
TREE EATER
A TREE AND BRUSH MASTICATOR

U.S. DEPARTMENT of AGRICULTURE
FOREST SERVICE
EQUIPMENT DEVELOPMENT CENTER
SAN DIMAS, CALIFORNIA

ED&T 1222 //

U.S. Department of Agriculture, Forest Service
Equipment Development Center, San Dimas, California 91773
January 1970

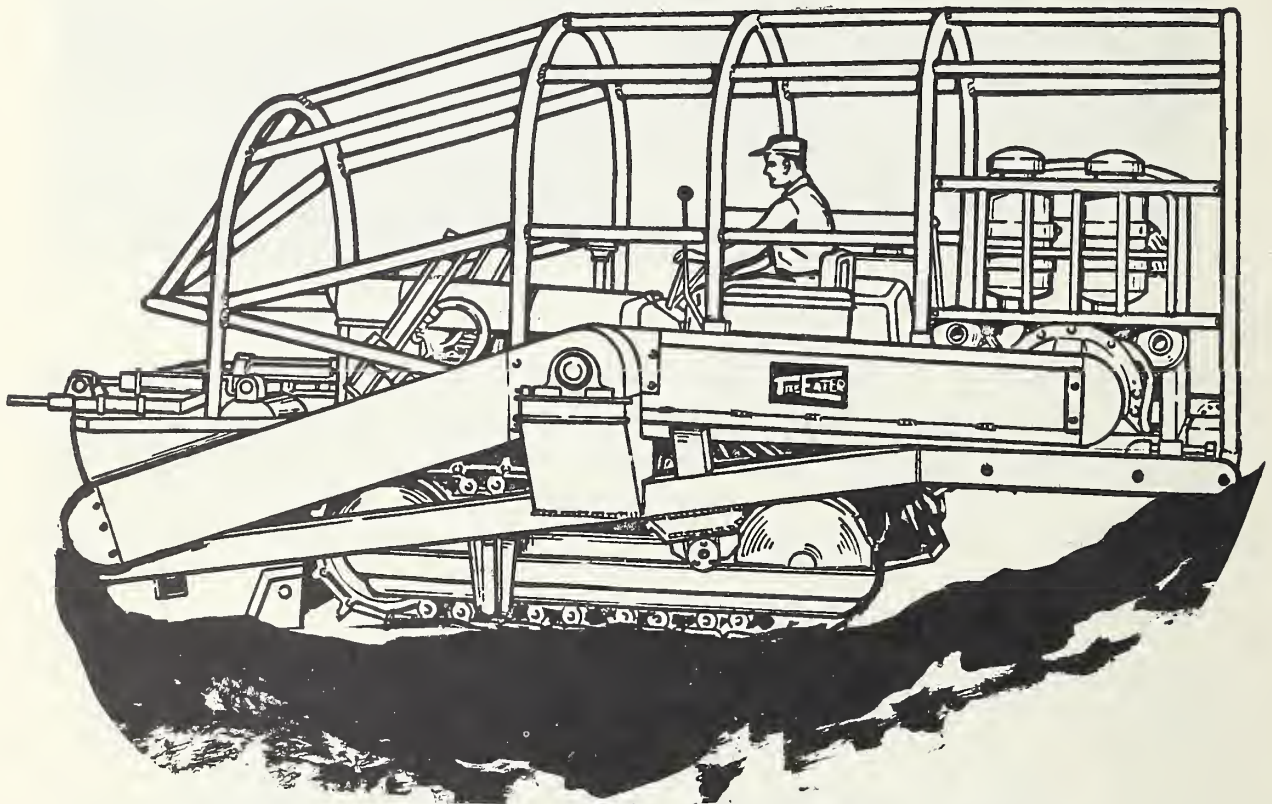
Figure 9. Illustration of how the Tree Eater can get trapped in a gully

Difficulties can also be encountered in areas with abrupt changes in slope created by ditches and gullies. When the machine crosses such areas, the additional overhang of the Tree Eater can cause the machine to hang up. The characteristic action for this is for the machine to enter a gully in a position perpendicular to its channel to the point where the cutter drum digs into the forward slope. When this happens, the operator raises the front with the hydraulic control. This, in turn, causes the back of the Tree Eater frame to drop because of rotation on the carrying pivot. If the machine cannot clear the forward slope, the loss of clearance of the rear overhang makes it almost impossible to back up the slope to the rear. Good judgment is required when working on this type of terrain, and even then the operation will necessarily be limited.

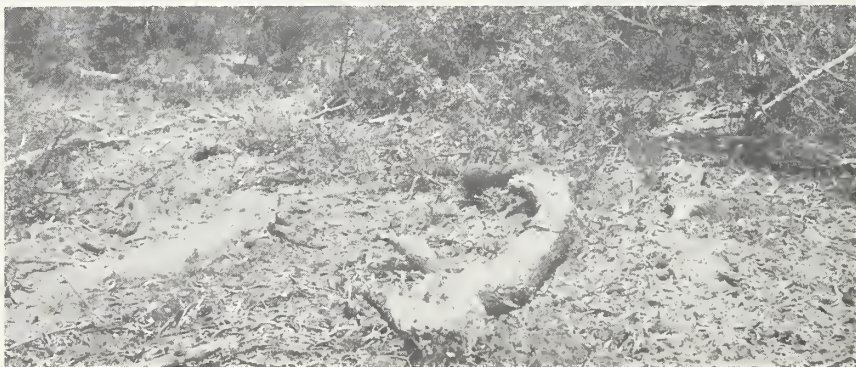
Because of the need in some areas to run with the cutter set at 4 inches or higher for good bit wear and to prevent breakage due to rocks, some of the smaller stems may not be completely chipped once they are felled. For larger logs, only the exposed upper surface is removed and chipped.

Figure 14. Only the upper portion of an oak trunk was stripped off with a high cutter setting

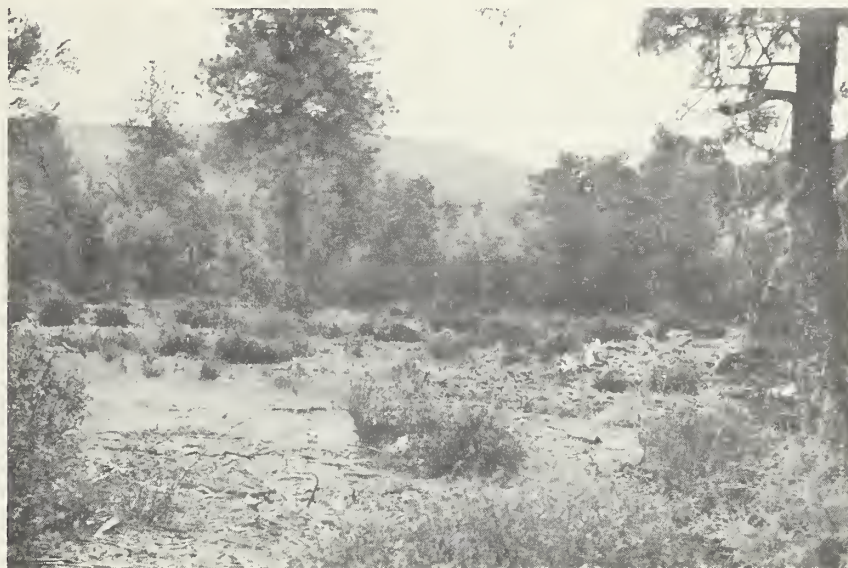
Sprouting brush species cut at the 4-inch-plus height show considerable resprouting. Figure 15 shows the extent of resprouting and growth after the area was cleared with the Tree Eater. The time interval between the clearing operation and the condition shown in the photograph was two years. Where the resprouting is not desirable for cattle or game browse, it can be effectively controlled by chemical sprays because of improved access and the low height of the growth.

Figure 15. Resprouting after clearing with the Tree Eater

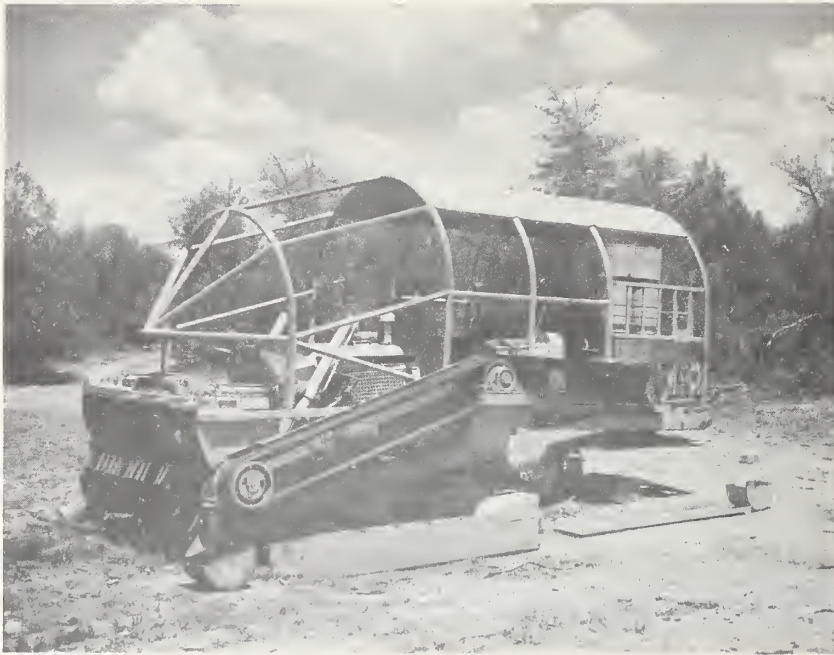
When the Tree Eater was delivered to the Forest Service, it was equipped with two sets (front and back) of ten matched individual V-belts. In less than 100 hours of operation the first set of belts had to be replaced because of breakage. After 134 total hours of operation (including time on the first set), several belts of the second set had become so damaged they had to be removed before they broke.

There were two major reasons for this extremely short belt-life, both causing the belts to turn over and run upside down. The first cause was the imposing of severe

Figure 16. Guards off, showing both front and rear sets of belts

pulsating and shock loads on the belts by the inertia of the cutter drum and the high torque of the engine. Under these conditions V-belts will whip laterally and enter the sheave grooves at an angle, causing them to turn over or even come off the sheaves. The second cause for belt failures was related to small sticks and other trash collecting in the belt guards and eventually working between the belts and sheaves. This trash entered through the coarse $\frac{1}{4}$ -inch-mesh screened areas provided by the manufacturer for ventilation, as well as through loose-fitting joints in the belt guards. To overcome this problem the operator added a fine-mesh window-screen material over the existing screens and sealed all other openings as well as possible.

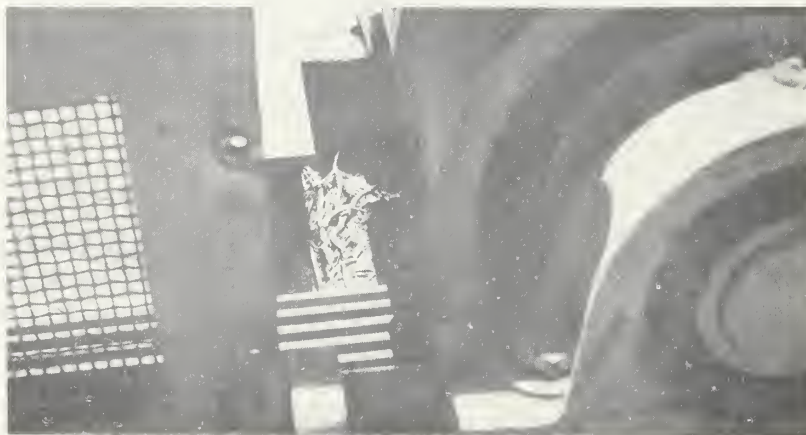
Figure 17. Trash in belt area that could cause belt damage

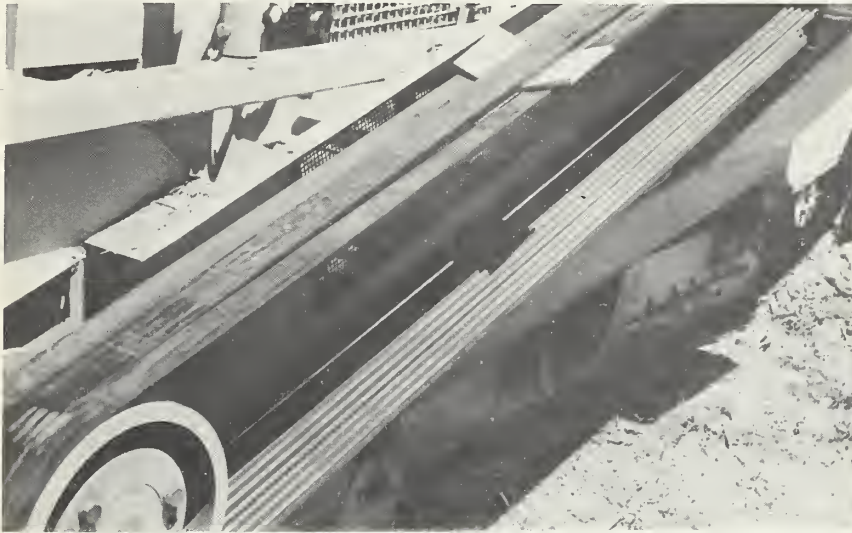
Figure 18. PowerBands made up in a set of 3-4-3

In order to overcome the belt-whipping problem the Tree Eater manufacturer recommended the use of the Gates Rubber Company's "PowerBand" belts. PowerBands are made by joining together several V-belts with a permanent high-strength tie-band. The tie-band forms a firm backing for the belts and ties them together to prevent belt flipping. For the Tree Eater the most suitable number of V-belts per PowerBand is five, so that a set of ten single belts is replaced with two PowerBands.

When the PowerBands are properly tensioned - as outlined in Appendix IV, "Power-Band Tensioning Kit Instructions" - and all trash is eliminated from the belt guards, good service life can be expected. At the end of the evaluation period the second set of PowerBands had over 174 hours of use without any notable problems. The first set was destroyed by a freak accident caused by a heavy limb being forced into the belt guard, bending it into the belts.

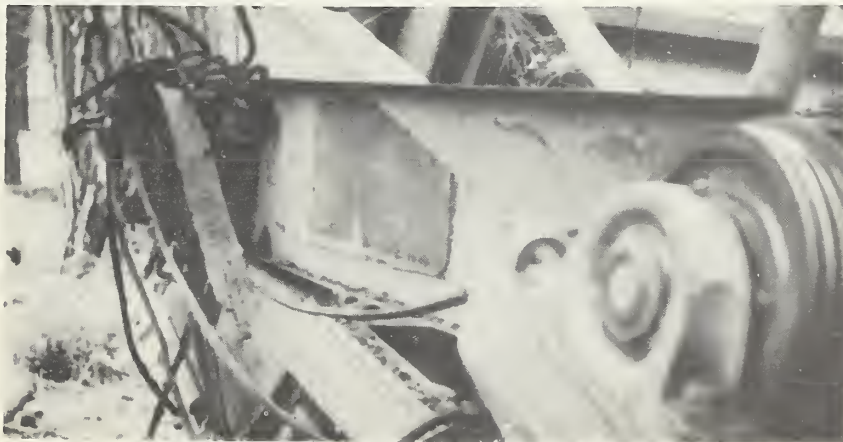
Figure 19. Broken belts resulting from guard being accidentally pushed into the PowerBands

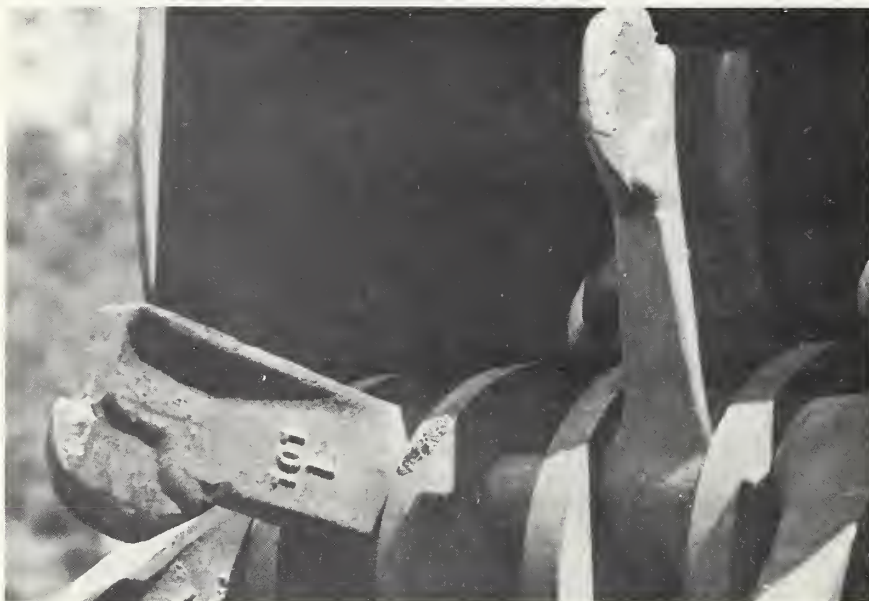
Maintenance of the cutting arm assemblies can be the highest single maintenance cost item for the Tree Eater. However, through careful operation, proper cutter-to-ground clearance, and proper maintenance, the cost due to wear and breakage can be held to a reasonable level. Proposed design changes by the manufacturer will also be aimed at reducing cutter maintenance cost.

Figure 20. Closeup of badly worn cutters

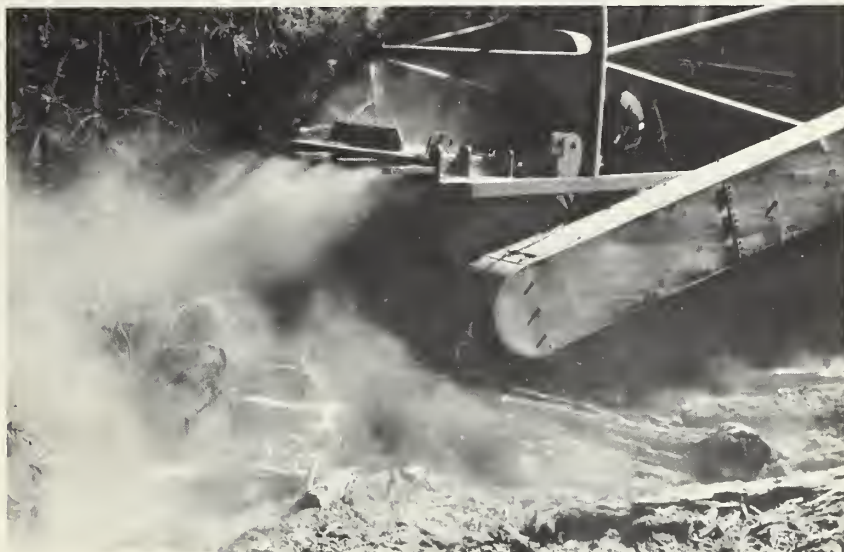
This wear is caused by a sandblasting effect created by the high velocity of the cutters as they pass through the clouds of soil particles and rocks surrounding the front of the machine, as shown in figure 21. This condition seems to be a greater factor than the type of wood or the size of trees and shrubs being cut.

Figure 21. Cutting drum being subjected to sandblasting effect

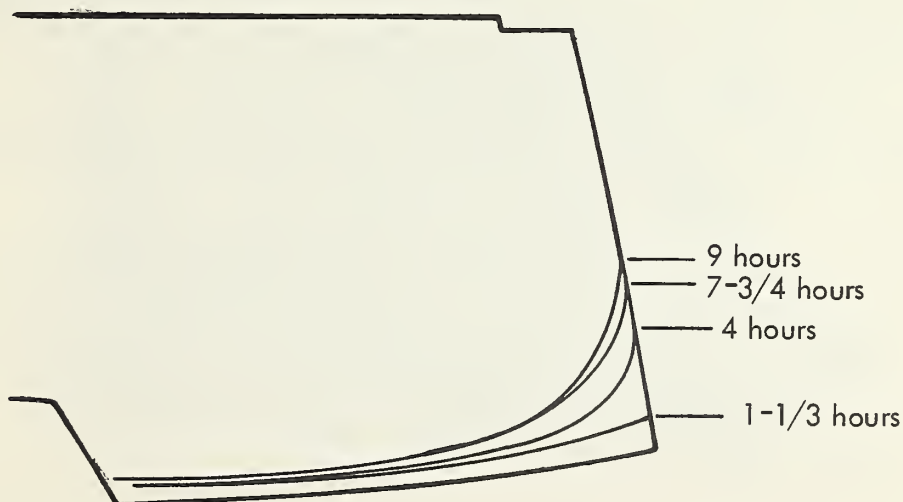
During the pilot operation, wear, not breakage, was the biggest problem with the knives, although some breakage did occur. When working in dry, abrasive soils, such as decomposed granite, with the cutters set to within 2 to 4 inches of the ground, wear can only be termed excessive, as illustrated by Figure 22.

Figure 22 shows the wear pattern for a new knife (not rebuilt with hard-facing) that was on the machine during the 1966 field test. As shown, the rate of wear decreases at a fairly rapid rate as the sharpness of the point and edge is lost. Rebuilt bits showed similar wear characteristics to those of new bits. During a 9-hour test period represented by figure 22, the cutters were subjected to about the worst operating conditions that would ever be encountered.

Figure 22. Wear pattern for a new cutter bit when working in decomposed granite soil

Considering the short life of these knives and the fact that no noticeable chipping or cracking of the hard-facing has occurred, it should be possible to go to a harder facing material. One system that may extend the life of the knives would be to use a rod similar to Airco 388 (52 to 55 Rockwell "C") for buildup, then follow with a final pass of Airco Easyarc 620 (approximately 65 Rockwell "C") or equal for the hard-facing. If chipping occurred, a lower hardness rod in the range of 60 Rockwell "C" could be used for the hard-facing. The aim should be to extend cutter life to at least 100 hours under severe operating conditions.

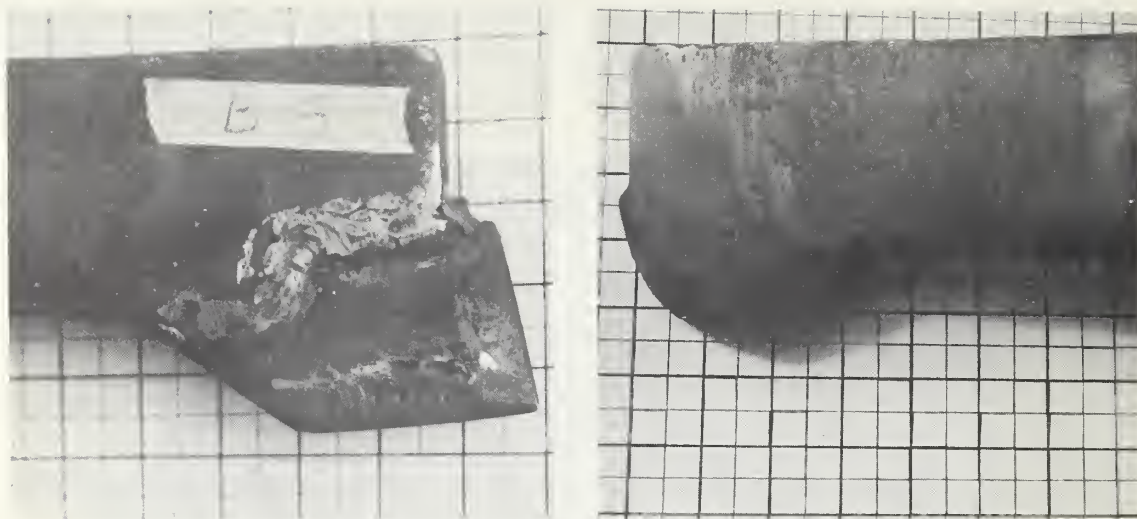
Figure 23. Comparison of new cutter (left) and badly worn one (right)

During the pilot operation the average life of the cutters, before being rebuilt, was approximately 40 hours. One set of rebuilt cutters lasted only 20 hours. This set was built up by using alternate passes of hard rod (Airco 388 or equal) and low hydrogen rod. In contrast, one other set of rebuilt cutters lasted approximately 90 hours when working in an area for the disposal of dry pine slash lying on a clay-type soil. The type of hard-facing for these knives is not known.

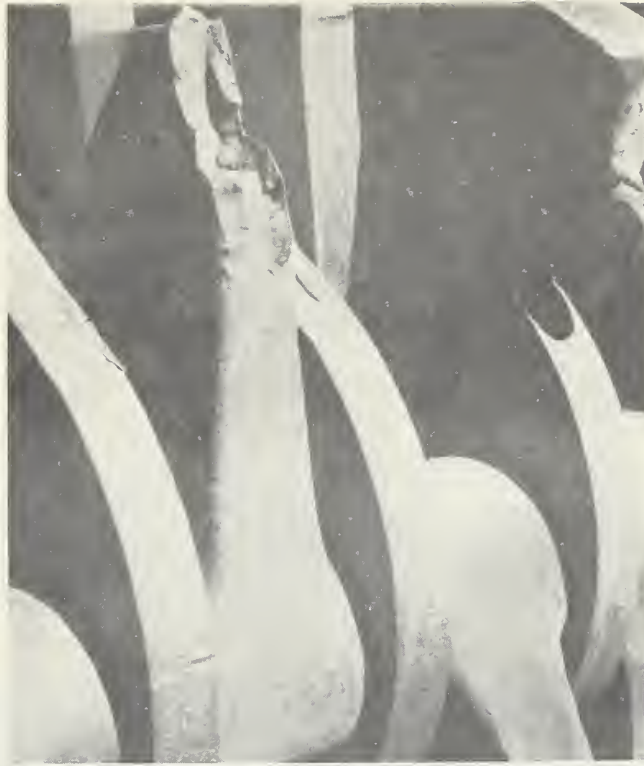
Also, the number of times a cutting bit can be rebuilt seems to be limited. A set of cutting arms that have had the knives rebuilt four times showed a tendency to break at the arm-to-bit weld as well as for the bits to break more frequently. After the third rebuilding the old bits should be cut from the arms and new bits welded on. These problems could also be overcome by developing cutter arms that would accept replaceable bits held by a mechanical means.

Figure 24. Arm with missing bit

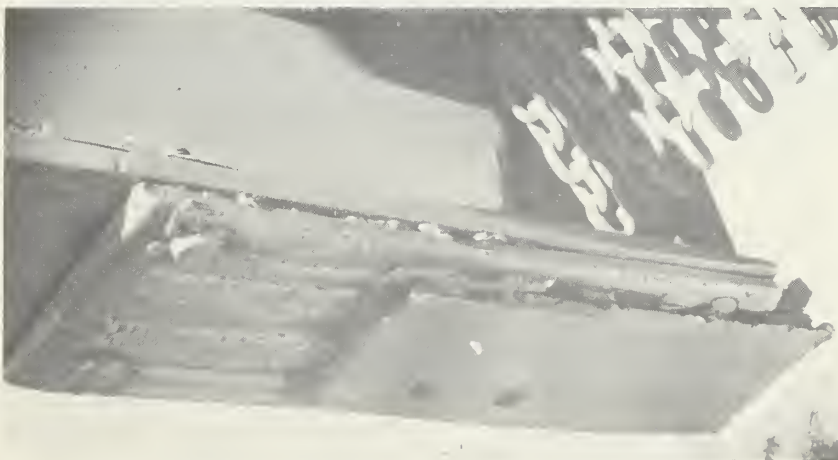
During early use of the Tree Eater it was noticed that excessive wear was occurring to the skid shoes that support the cutting drum. Although the shoes were made of $\frac{3}{4}$ -inch steel, they wore completely through in 118 hours of use. For repair the operator designed soleplates (of $\frac{1}{2}$ -inch steel with solid hard-facing laid on the bottom surface) that are mounted to the shoes by four $\frac{1}{2}$ -inch-diameter studs. Even with

Figure 25. Hard-faced skid shoe with soleplate added for increased life

the solid hard-facing these soleplates lasted less than 20 hours when working in decomposed granite. The operator then secured a piece of old snowplow blade 3/4 of an inch thick, fabricated a new set of soleplates, and mounted them to the skid shoes. These wear plates lasted for about 52 hours of operation, or about three times longer than the hard-faced soles.

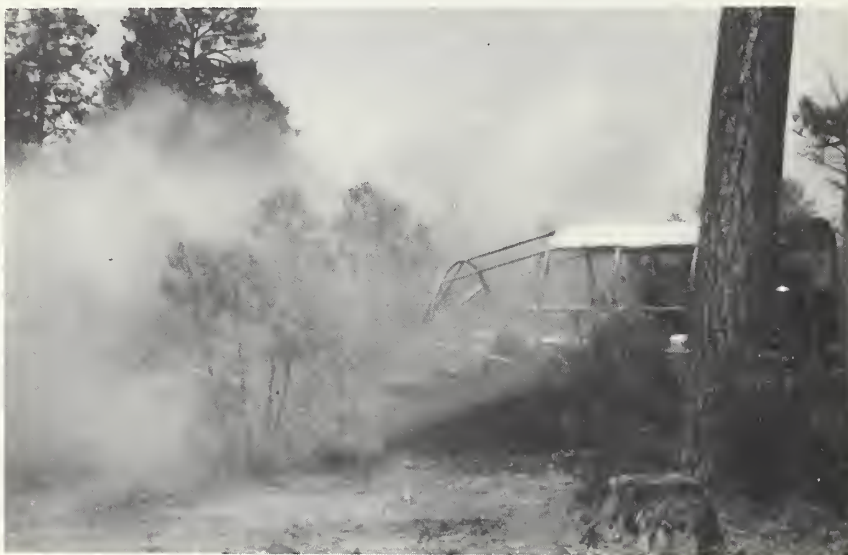
Figure 26. Dust condition existing around Tree Eater

From figure 26 it can be seen that the dust is of sufficient density to obscure the operator's vision from time to time, particularly when he is working downwind. This makes it necessary that a swamper or relief operator always be present to help guide the operator from the sidelines. During the test it was easy to see that some form of radio communication should be provided under these conditions. The noise level of the machine is too high (over 95 decibels) for vocal commands, and vision is sometimes impaired. Although a complete analysis was not made during the test, the level of 90 and 95 db on both the B and C weighing scales was common at distances of from 40 to 80 feet from the unit. This would place the actual sound

Besides limiting vision, the dust cloud would seem to present a potentially serious health hazard. To establish the extent of the hazard, tests would have to be run to determine the free silica content of the soil and the actual dust concentration at the operator's position. In a test by the California Department of Public Health, figures shown for a brush-clearing job done with a D-7 dozer during warm, dry weather exceeded the safety standards by more than tenfold.

To help protect the operator, an Air Boy helmet (Jo Art Industries, Box 8127, Stockton, California) with filter system was added to the machine. This unit definitely reduced the dust hazard to the operator but also reduced his efficiency. The helmet further reduced the wearer's contact with the outside world by impairing both hearing and vision. Also, it is necessary for the operator to take breaks or rotate with a relief operator just to get out from under the "hat." Frequent, careful cleaning of the clear face shield is also necessary to keep light diffraction to a minimum.

If the machine is to be worked in any area that may present a dust problem, it is recommended that the unit be equipped with an air-conditioned cab that will protect the operator from dust and noise. At least the front windshield should slope inward at the bottom to reduce dust collecting on the outside surface. Two-way radio communication is recommended for use between the operator and the swamper. To safeguard the machine, a solid steel belly pan should be provided under the GMC diesel
